TIMBER POLE DEEP PILE FOUNDATION

Avon River Precinct, Christchurch, NZ

A Deep Pile Foundation was installed for the Convention Centre Punt Stop and River Wall as part of the Avon River Precinct development, in earthquake-affected Christchurch.

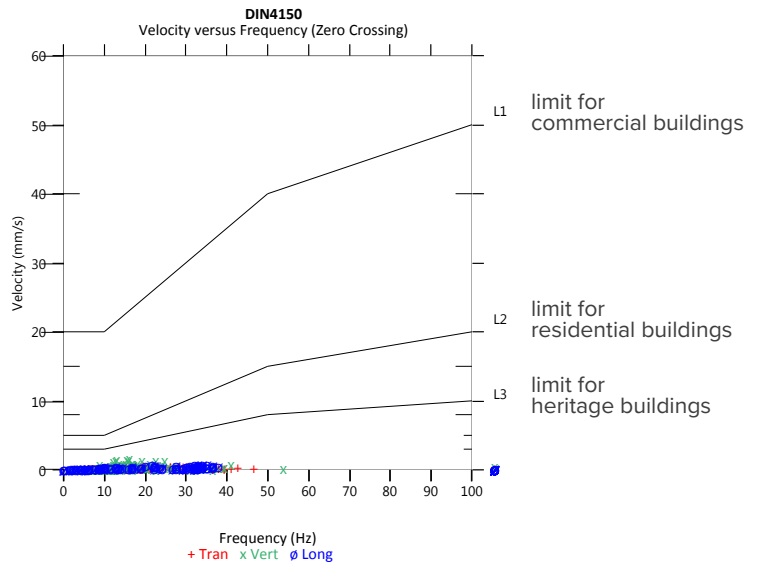
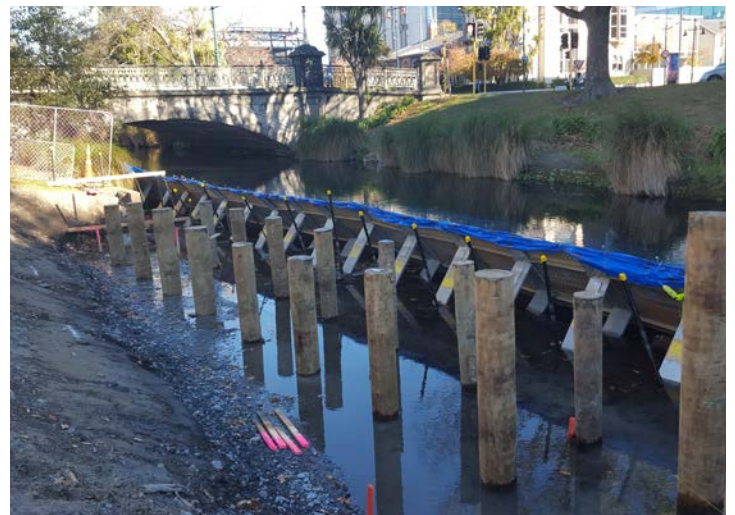
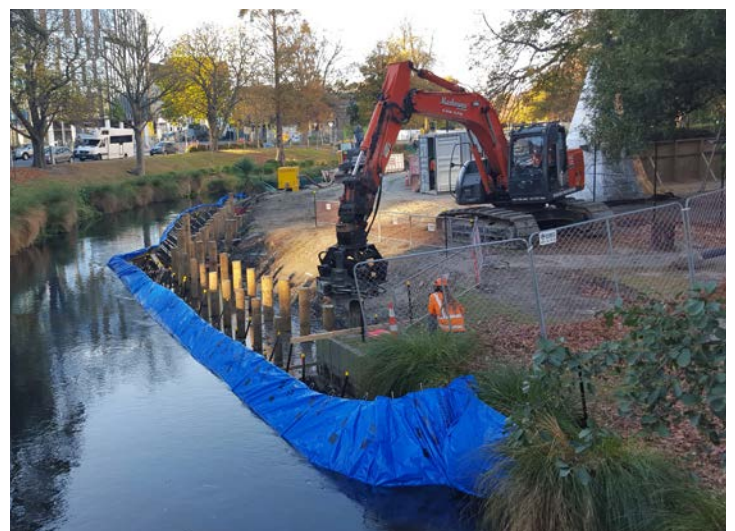
Figure 1

- The recorded vibrations were evaluated against DIN4150 to confirm the piling did not reduce the serviceability of the heritage building.
- A comprehensive compliance report was produced at the completion of the piling, and a summary of the results is shown in Figure 1.

- Vibration monitoring of the heritage building, using professional, independently calibrated equipment, needed to be carried out for the full duration of the piling.
