# TIMBER POLE DEEP PILE RETAINING WALLS

## New Mitre 10 store, Beachlands, Auckland, NZ

## Project background: New Mitre 10 store, Beachlands, Auckland, NZ

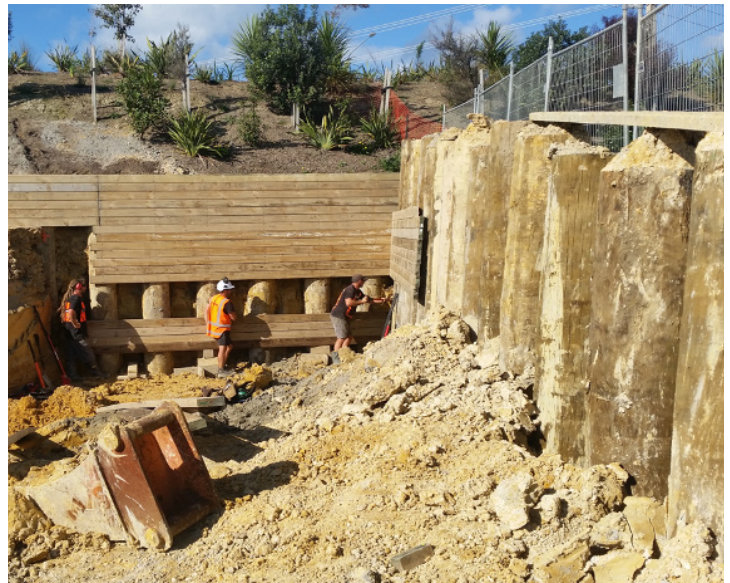
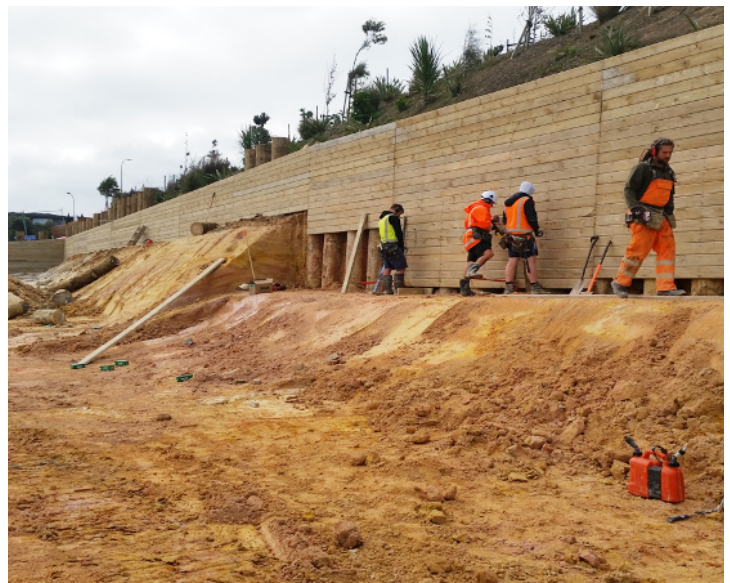
- Before excavation the TTT SED Poles were drilled into the sand stone and concreted in place.
- The retaining walls were built from the top down, in 1.5m deep sections. After the poles were installed a section of wall was excavated, the poles exposed, and timber rails affixed with s/s washer head screws.
- This method of installation meant the poles retained the bank while the wall was completed safely from the other side. There was no disturbance to the roadway above.
- The retaining walls were completed in 3 weeks – well under the clients expected timeframe.

- TTT SED Poles, H5 treated, 10.0m x 400mm SED, 166 pieces, were used for the retaining walls.
- The poles were TTT tested proof tested to prove their strength.
- TTT SED Poles are naturally tapered, machine-peeled poles. Minimal wood is removed during processing so each pole retains its strength.
- TTT Timber, H5 treated, 150x50mm, arrissed-edge SG8, was used for the retaining wall rails. The timber was machined to a constant width of 148mm so when installed the horizontal lines all matched. Jacks were also used to ensure the timber fit tightly against adjacent boards.
- Wall 1 was 60m long up to 3.8m high.
- Wall 2 was 94m long up to 4.8m high.
- Wall 3 was 12.4m long up to 2.8m high.
